# REPORT # 03/09/101 803

- Aug 17 2010

M.T.O. Meeting

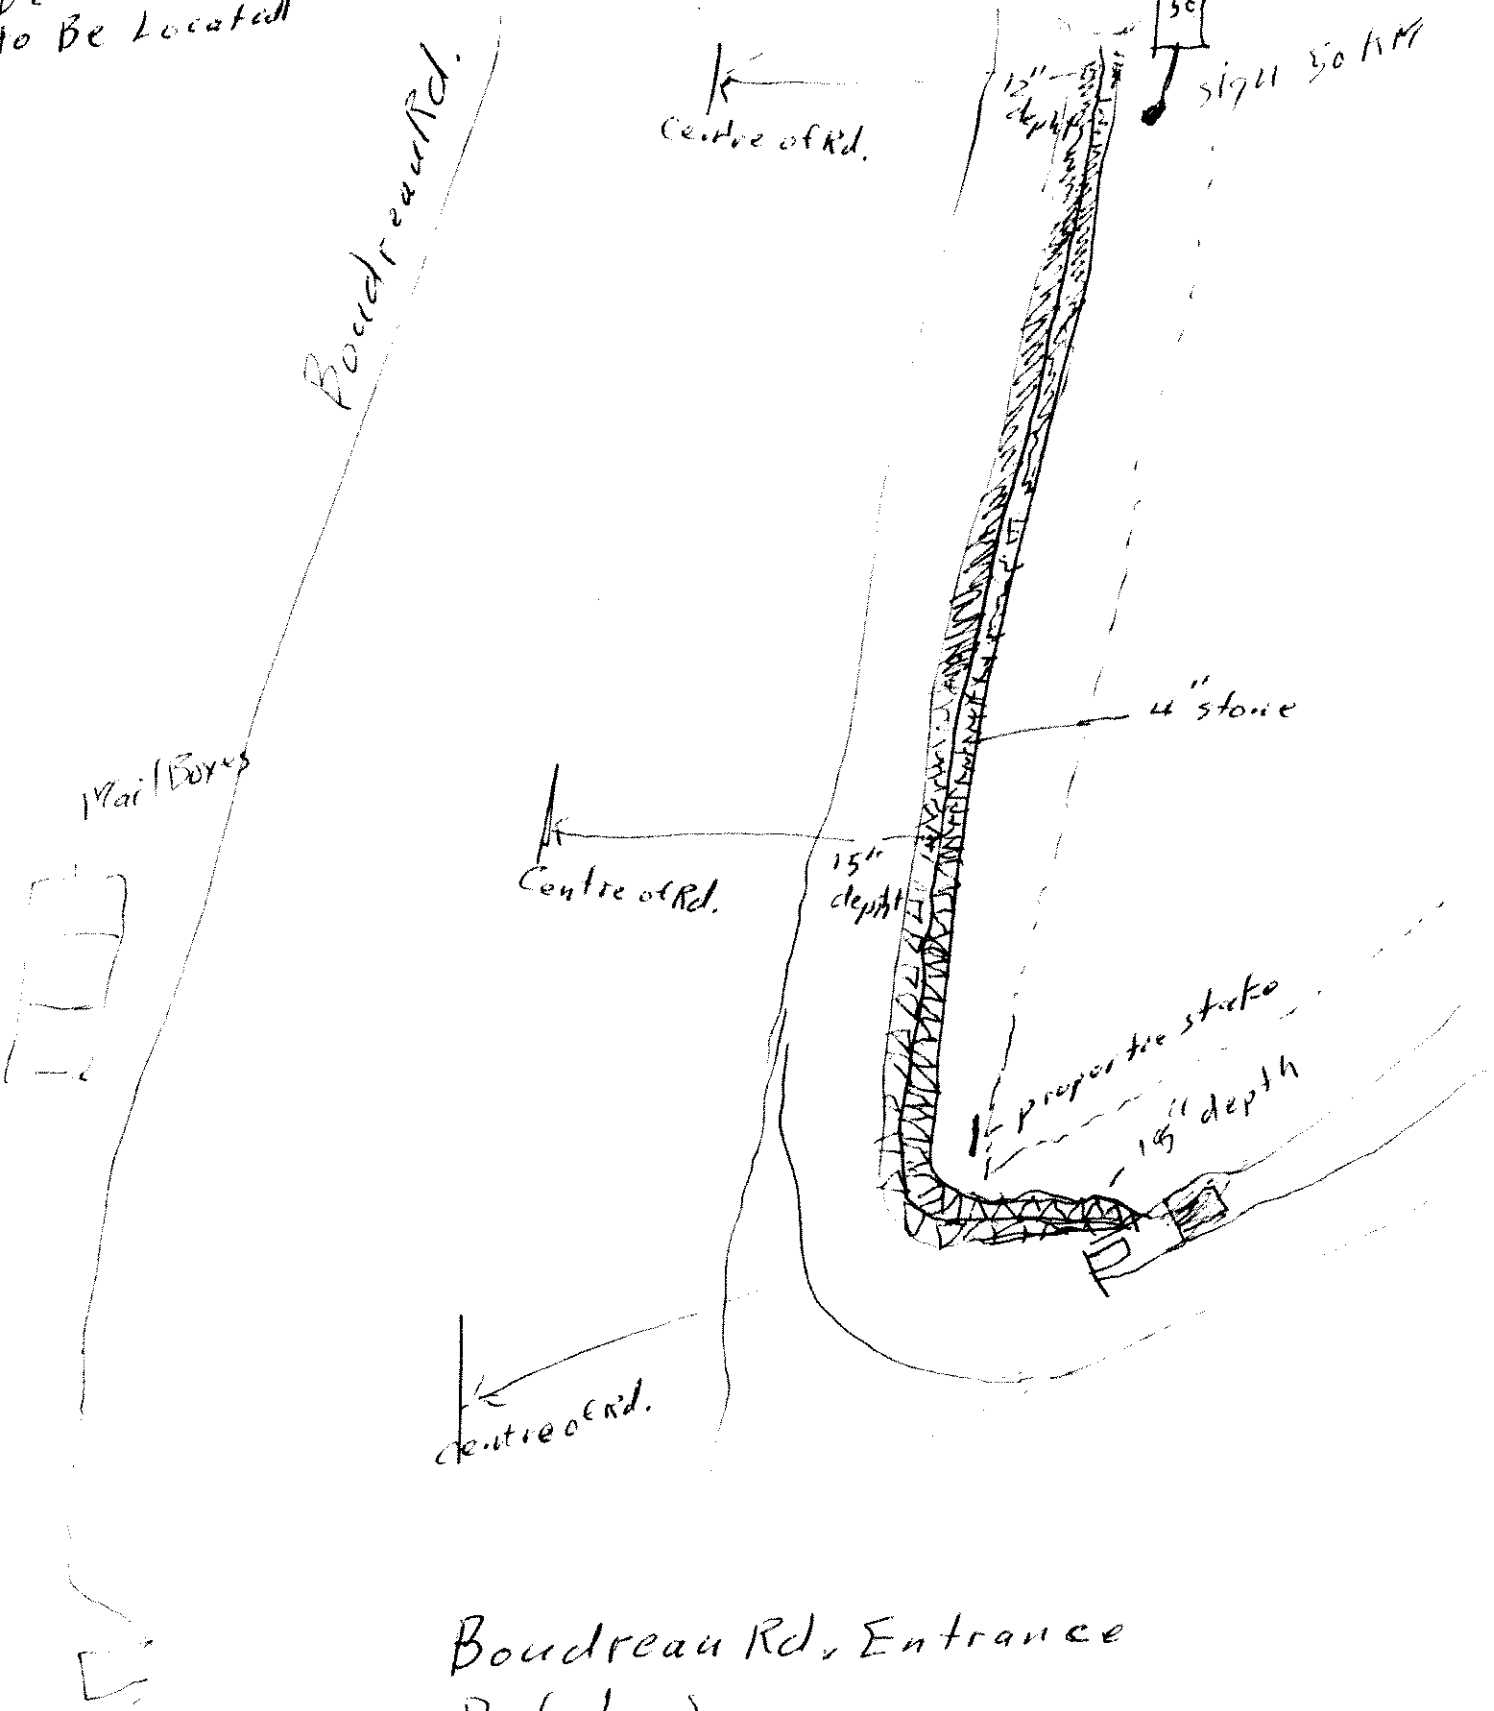
Boudreau Rd. Entrance  
Pitch from

Bellwires have to be located

4" stone

15" depth

proper toe stroke  
10" depth

Hury Entrance to Wain  
Aug 31 - 2010
